**PRELIMINARY ASSESSMENT/
VISUAL SITE INSPECTION**

**SYNTHETIC PRODUCTS COMPANY
CLEVELAND, OHIO
OHD 077 783 603**

FINAL REPORT

Work Assignment No.	:	C05087
EPA Region	:	5
Site No.	:	OHD 077 783 603
Date Prepared	:	September 1, 1992
Contract No.	:	68-W9-0006
PRC No.	:	009-C05087OH3J
Prepared by	:	PRC Environmental Management, Inc. (Tom Sinski)
Contractor Project Manager	:	Shin Ahn
Telephone No.	:	(312) 856-8700
EPA Work Assignment Manager	:	Kevin Pierard
Telephone No.	:	(312) 886-4448

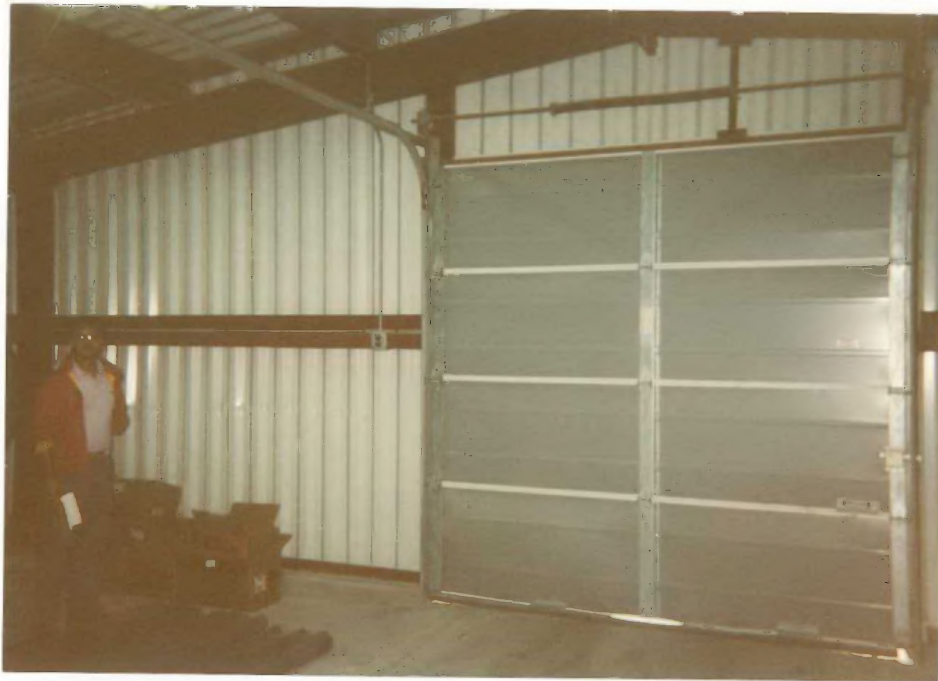
The building appeared in good condition during the VSI. Small surface cracks were noted in the floor in the vicinity of the sump. During the VSI, no evidence of any release was visible. The building currently is being used to store construction materials (PRC, 1992).

Photograph No. 1
Orientation: South
Date: April 20, 1992
Description: The photograph shows the interior of the former hazardous waste drum storage building. The garage door is the fork lift entrance.

PRC recommends no further action.

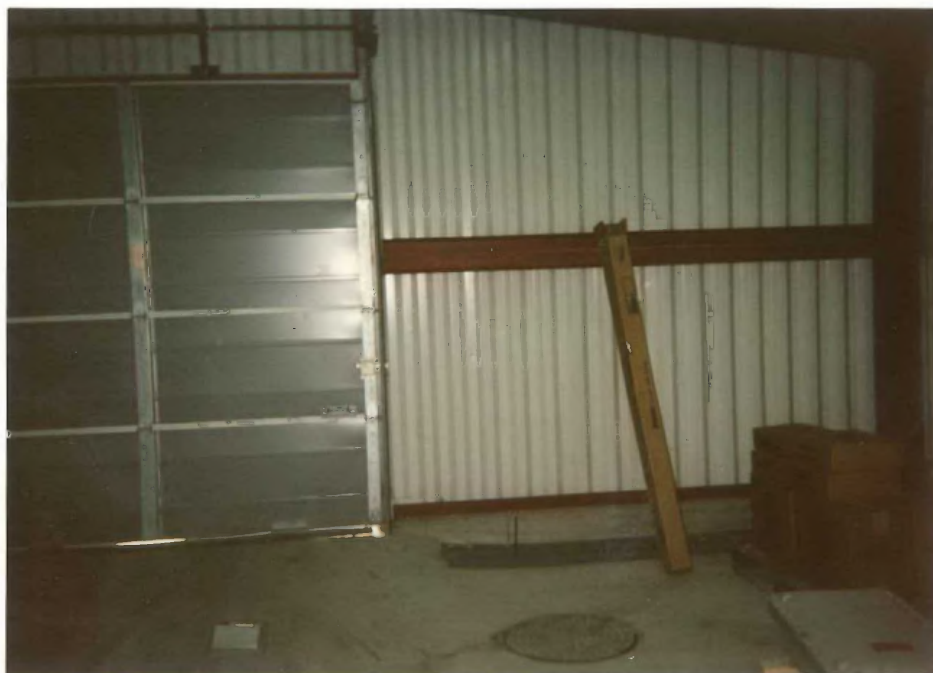
Photograph No. 2
Orientation: South
Date: April 20, 1992
Description: The photograph shows the interior of the former hazardous waste drum storage building. Sump inside the building is shown in the base of the photograph.

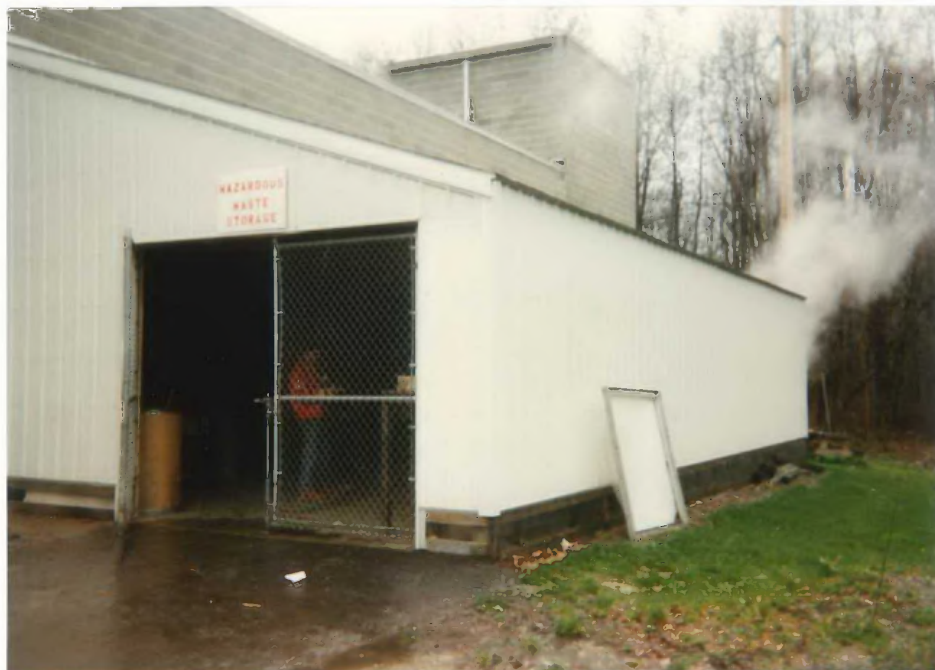
Photograph No. 3

The unit is a single building separated from the manufacturing plant. It is located on the north side of the property and west of the manufacturing building. The building has aluminum siding with a concrete ramp that provides access for a fork lift. The ramp leads to a garage door on the south side of the building. A ramp inside the building descends to the concrete floor. The concrete floor is 30 feet by 30 feet, with a 5-inch concrete berm around the perimeter of the floor. The berm is part of the concrete floor. Consequently, there are no spaces, cracks, or gaps between the floor and the berm. There are two sumps, one on each side of the ramp inside the building. The sumps and berm act as secondary containment. The capacity of the drum storage building is eighty 55-gallon drums or 4,400 gallons. (See Photographs No. 1, No. 2, and No. 3 in Attachment B.)

Description: The exterior of former hazardous waste drum storage building

Location: SWMU 1

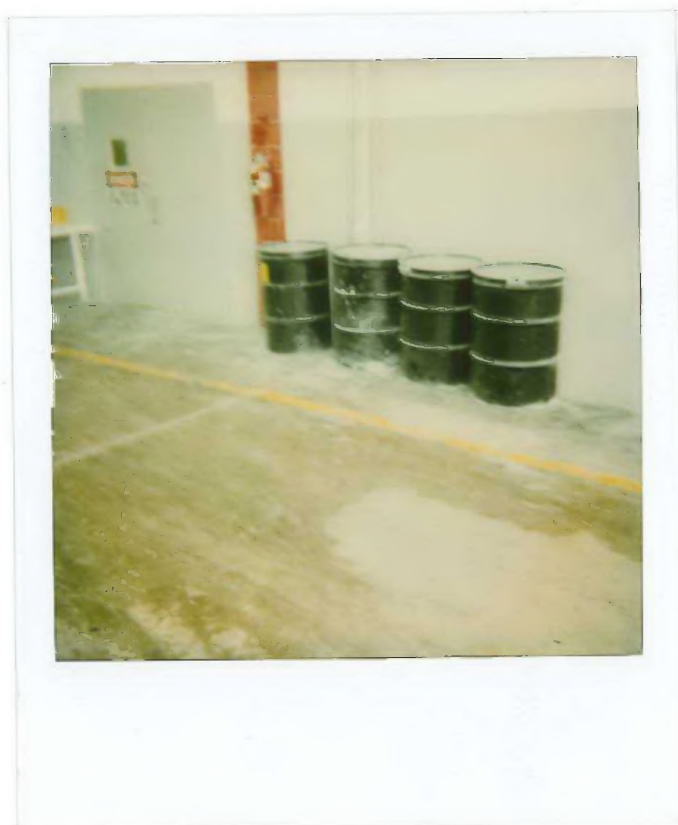
Photograph No. 4

Observations: The unit appeared in good condition. Small surface cracks were noted in the concrete floor. There was no evidence of any releases noted during the VSI.

Description: Hazardous waste drum storage area

Location: SWMU 2

PRC recommends repairing the surface cracks near SWMU 2. PRC also recommends improving the secondary containment for SWMU 2 by either sealing the drain near the SWMU or building a dike or berm around the SWMU. A second option for improving the secondary containment would be to store drums containing hazardous waste in SWMU 1, the former hazardous waste storage building, since it was designed for this purpose.

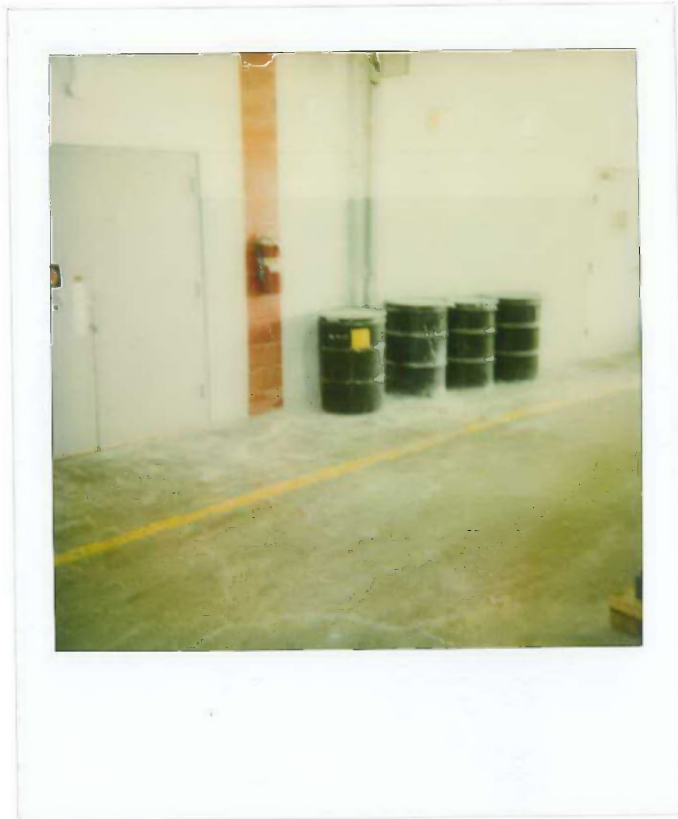
Photograph No. 5
Orientation: South
Description: Hazardous waste storage area

Location: SWMU 2
Date: April 29, 1992
